# The Scientific Preservation of the Mural Paintings at Siva Temple, Peruvanam, Cherpu, Thrissur District: Preserving the History and Promoting the Culture

<sup>1\*</sup> Assistant Archaeological Chemist, Science Branch, Chennai, Archaeological Survey of India

<sup>2</sup> Assistant Archaeologist, Archaeological Survey of India, HQ, ASI, New Delhi. (Email: rahulkuttantvm@gmail.com, vinuraj777@gmail.com)

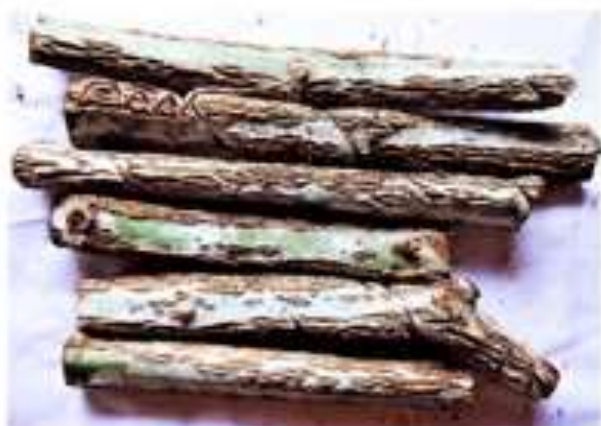
*Oonjal Valli (Cissus Glauca Roxb)*

As a prime requisite three binders in the form of natural gum extracts were selected for hit and trial method of experimentation. *Cissus glauca roxb* extract which is selected as one of the natural binder is prepared by crushing the same into chunks. The mass obtained is kept in a container dispersed in water for one week. After this span of time period, the liquid is decanted to draw out the extract. As a counterpart, Bael fruit extract was also preferred to substantiate the filling lime pack mode. Bael fruit is richly available in Kerala within the Temple premises. Once obtained or made available, the fruit is crushed to pieces and the mass obtained is boiled with water. The resultant supernatant liquid obtained thus is collected efficaciously and decanted to obtain Bael fruit extract. The third option focused on inclusion of tender coconut juice which is directly available from tender coconuts.

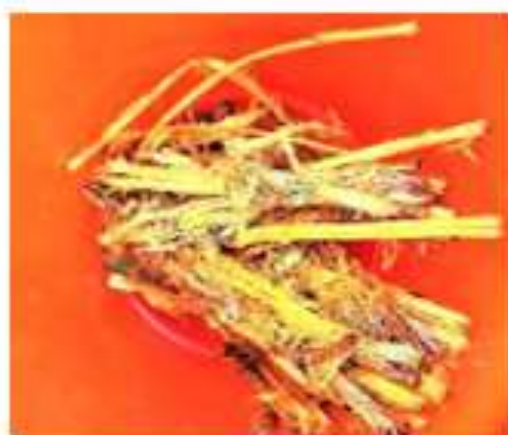
*Crushed Cissus glauca Roxb*

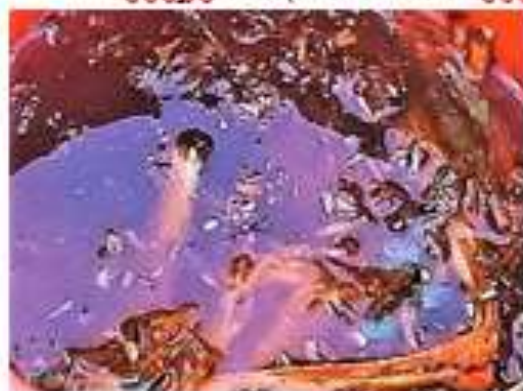
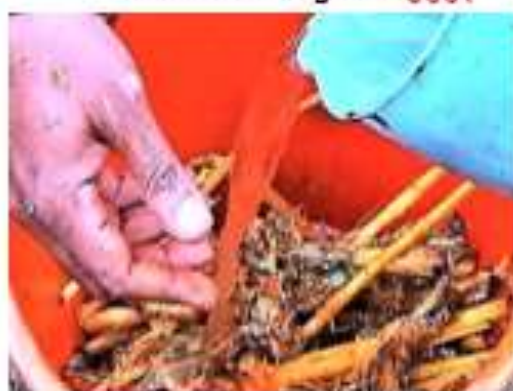
*The Supernatant binder extract decanted for the filling purpose*

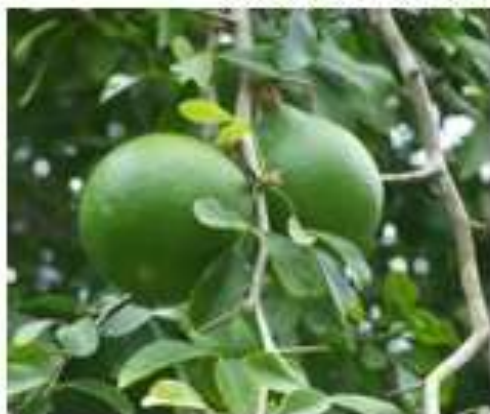
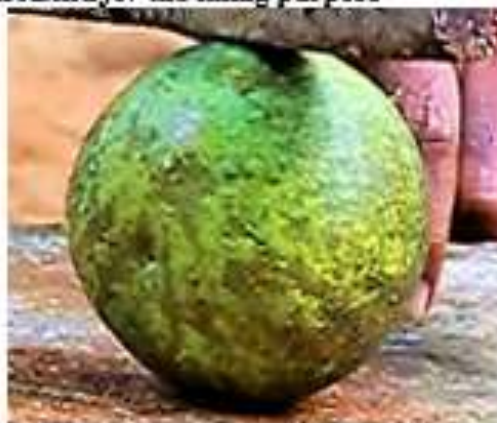
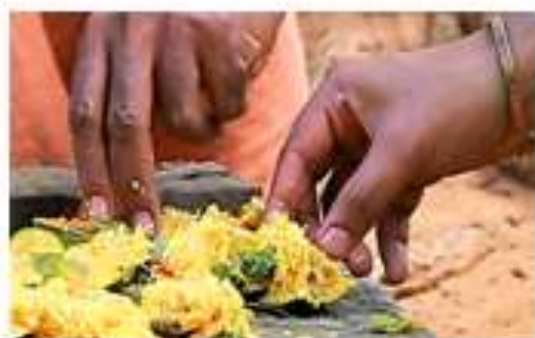
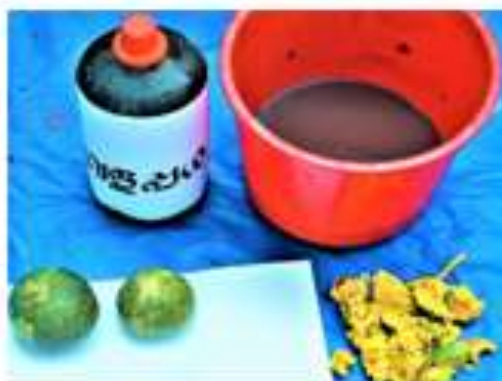
**Preparation of Bael extract (a) Bael fruit (b) Crushing Bael fruit to chunks (c) Crushed Bael fruit subjected to boiling with water to yield Bael fruit extract (d) The Supernatant binder extract decanted for the filling purpose**

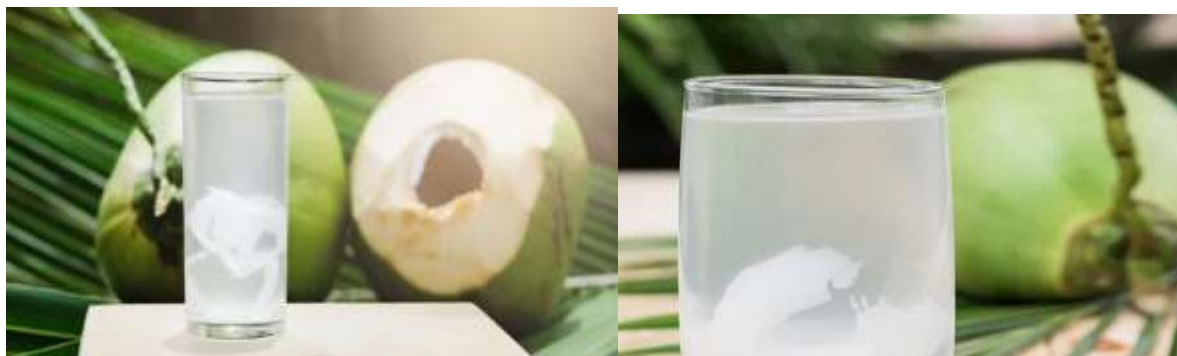
**(a) & (b) Tender coconut water. The same is used as such for binding purpose taking in account of its adhesive capacity**

The three selected binders were blended with lime water to form a glue type. All these three filling materials in the form of lime pack is applied over selected micro surfaces such as minor cracks and grooves on the murals. The three specimens were kept for examination for about a span of two weeks to check the compatibility and efficacy in binding to original structure. As per the examination, it was found that the filling material in combination with *Cissus glauca roxb* extract and tender coconut juice developed minor cracks whereas the combination of lime with Bael fruit extract remained intact and hence the same was selected for filling and filleting work at the mural on macro level basis.

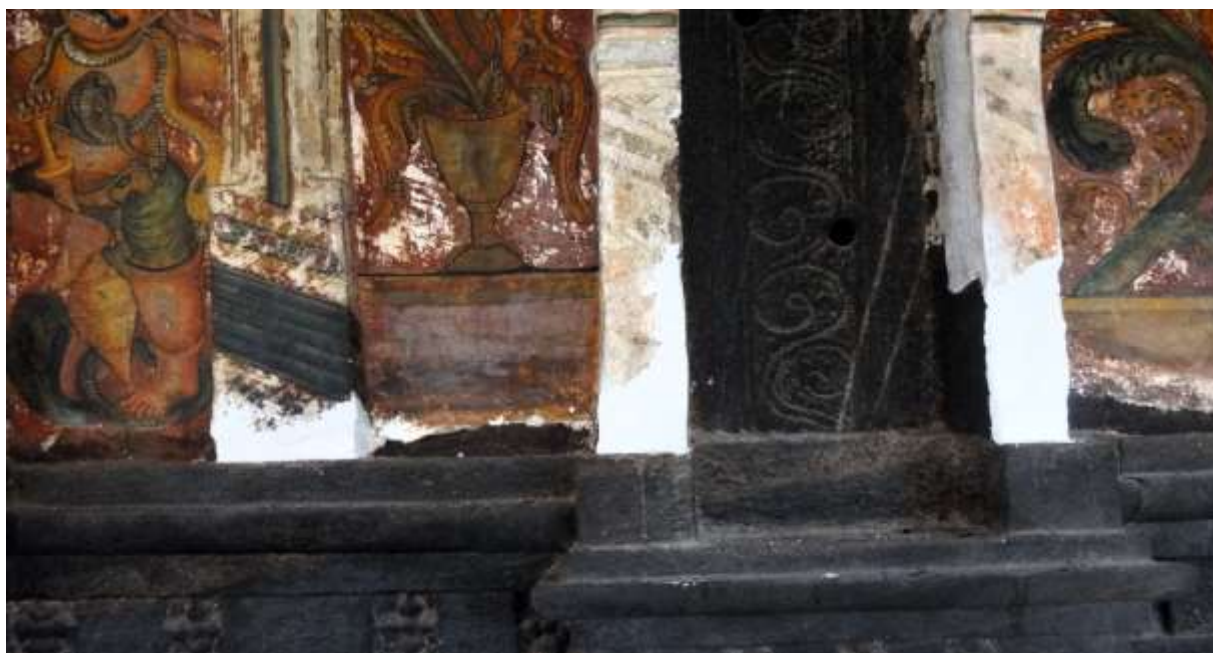
**Trial and error experimentation on micro level phase (a) Lime and *Cissus glauca roxb* extract (b) Lime with Bael fruit extract (c) Lime mixed-up with tender coconut water applied on the walls**

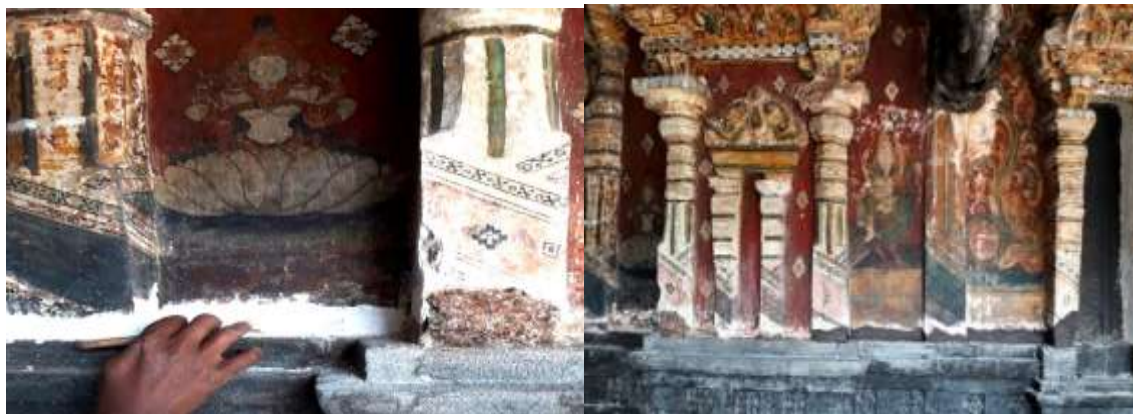
**(a) Filling work on the cracked base of the murals at Erattayappan at macro level execution phase (b) Further lime coating on the cracked fissures and grooves to accomplish white lime texture for feasible colour reintegration works**

As consequent to the results observed from the inspection method, the combination of the bael fruit extract and lime is applied on the broken portions, crevices, fissures, holes and grooves of the murals scaled up to macro levels as per the felt need for scientific preservation. Once applied on the broken portions, the contrasting texture of the filling material on drying owing to the presence of bael extract is matched with a superficial coating of lime water thus concealing the said surface in turn camouflaging with the original surface. The portions with larger bulged portions were filled up by mixing the same in liquefied form thus injecting into the grooves or holes developed on the bulged portions. As a pre-requisite to the injection method before the same, the surface of the cracks was strengthened by the facing method.

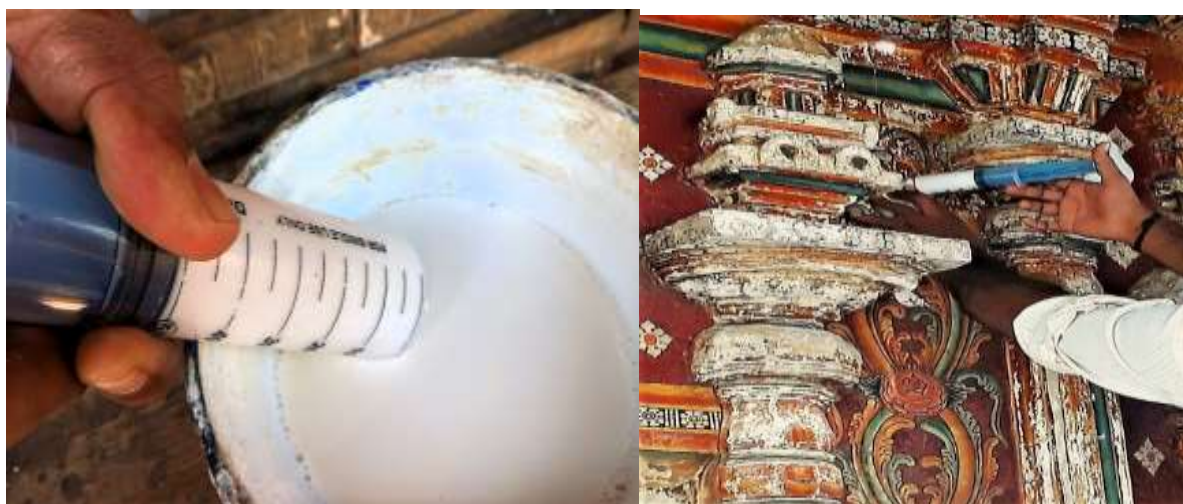
**(a) Filling work on the minor cracks and fissures of the murals at Erattayappan at by injection method- Diluted lime with binder extract taken in syringe for injection into the micro fissures under consideration (b) Injection of lime into the micro fissures to fill the hollow area of the ground**

This is done by fixing a muslin cloth over the cracked fragile bulged area with 1% Poly Vinyl Acetate (PVA) in Toluene. The application of the same on muslin cloth is exercised in criss-cross mode. The injection of the filling material is implemented to the small bore or hole as per the requirement within the proximity of the mural area where facing is accomplished. Once the filling vide injection was put into effect, the surface is levelled by taking extreme care and the facing is left for a stipulated period of more than 2-3 weeks. Once the

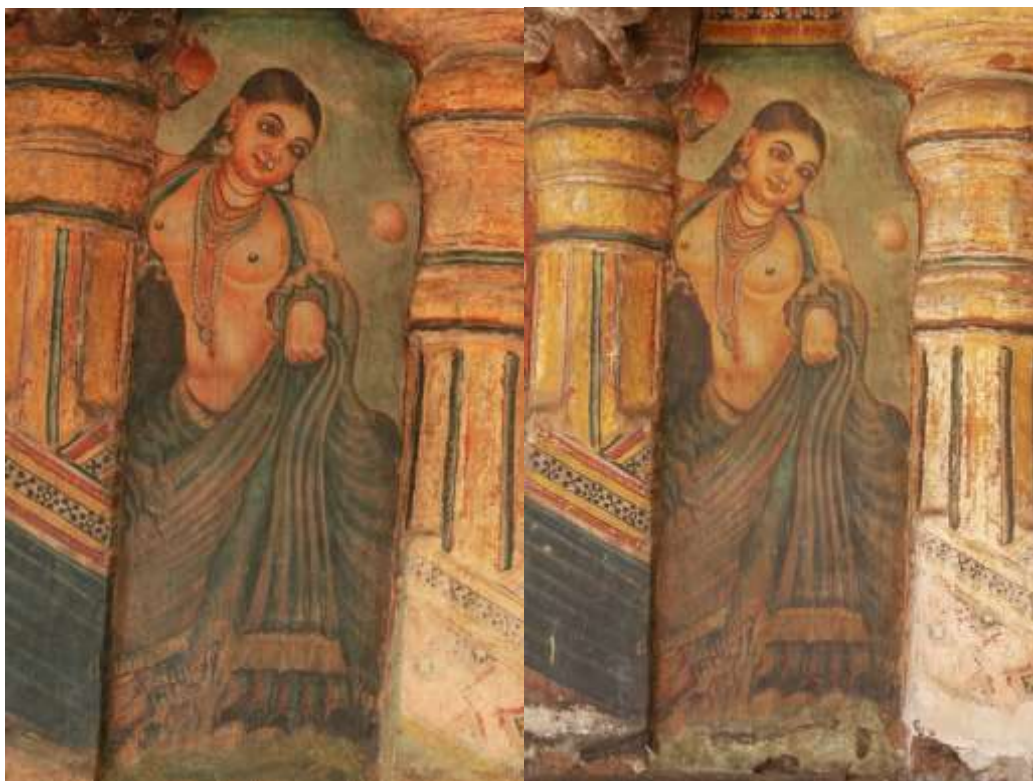
***Erattayappan Murals (Yakshi and Parashuarama) before and after preservation– A two-fold view of filling and filleting works at the basement of mural along with colour reintegration works. The after treated mural is preserved and protected from climatic vagaries using 1% PVA in Toluene***

Once all the preservation procedures on the *Erattayappan* murals are fulfilled to the core, measures are taken to protect and preserve the treated areas from the twofold effects of perturbed climatic parameters and carbonaceous gatherings. Such protective shielding is made possible only when there is adequate safeguard between the pigment layers of the mural surface with that of the outer environment. To attain this, a film of 1% Poly Vinyl Acetate (PVA) in Toluene was applied in criss-cross format with very soft brushes over the supernatant pigment layer of the mural surface. Poly Vinyl Acetate (PVA) being a polymer when applied on the surface forms an organic film over the surface. Being hydrophobic, it helps the pigment and further interior layers including ground from heavy rainfall and further climatic vagaries. By keeping the reversibility factor of scientific conservation ethics in mind, it is undoubtedly proven fact that the same coating can be revoked using Toluene or other organic solvents as and when required. The treated surface thus enhances safeguarding and sustainability quite appreciably from further deteriorating factors thus retaining the aesthetic beauty, and archaeological potential coupled with an extended life span of these supreme murals.

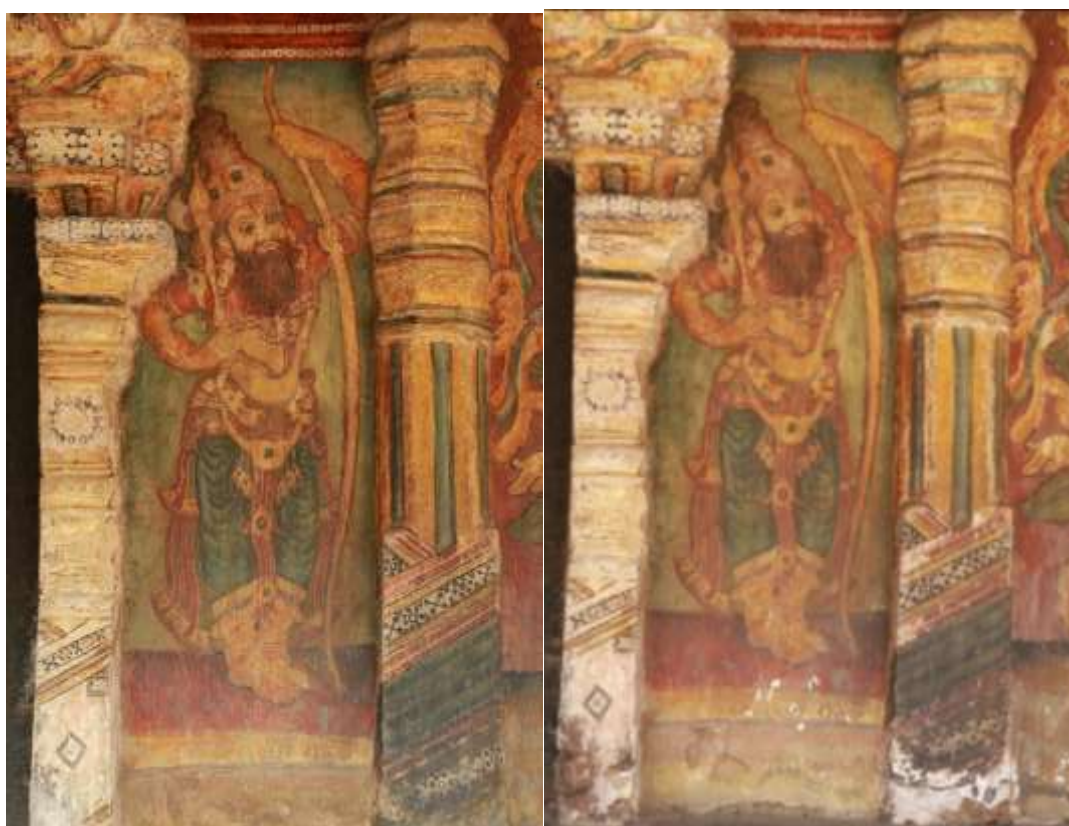
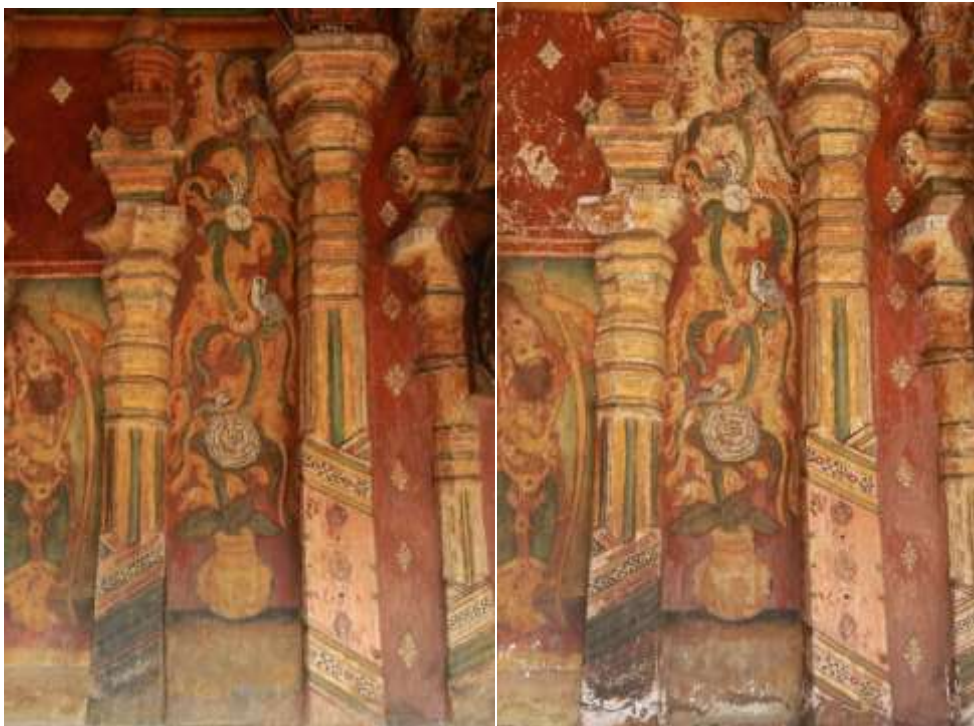
***Erattayappan Murals before and after preservation – A two-fold view of filling and filleting works at the foot of the mural coupled with colour reintegration works for both the floral motifs and iconographic depiction of Dakshinamoorthy of the related murals. The after treated mural is preserved and protected from climatic vagaries using 1% PVA in Toluene***

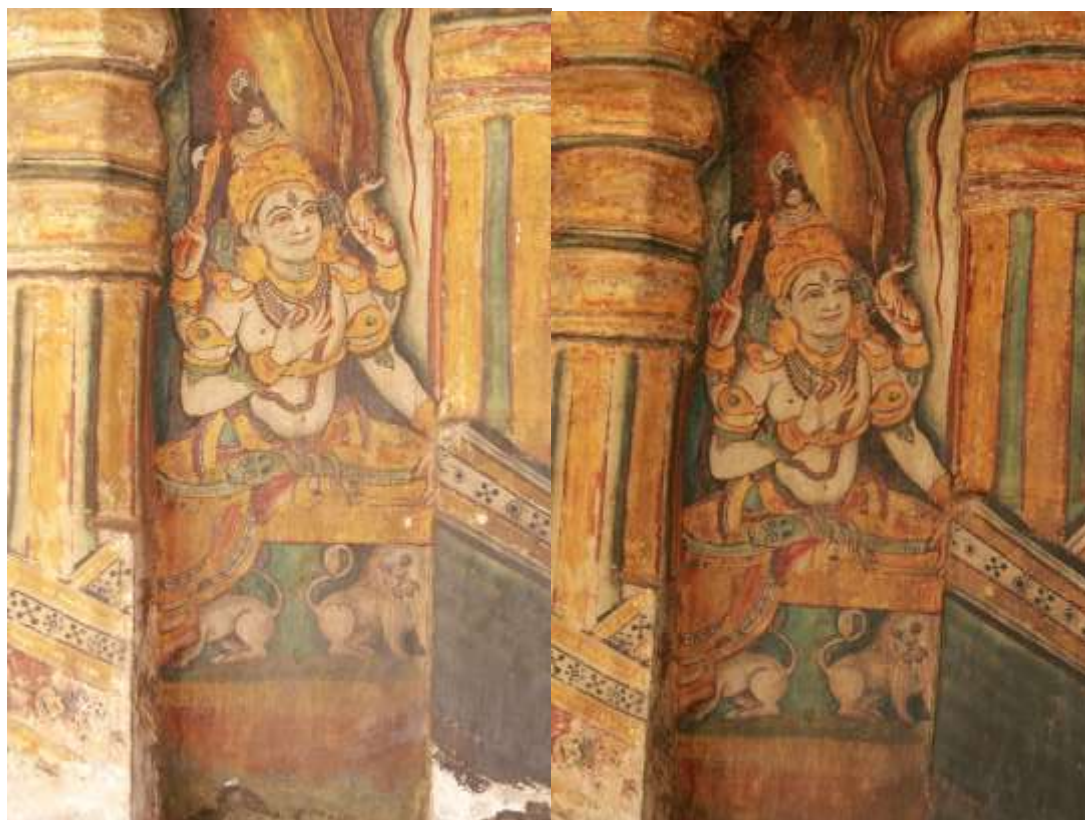
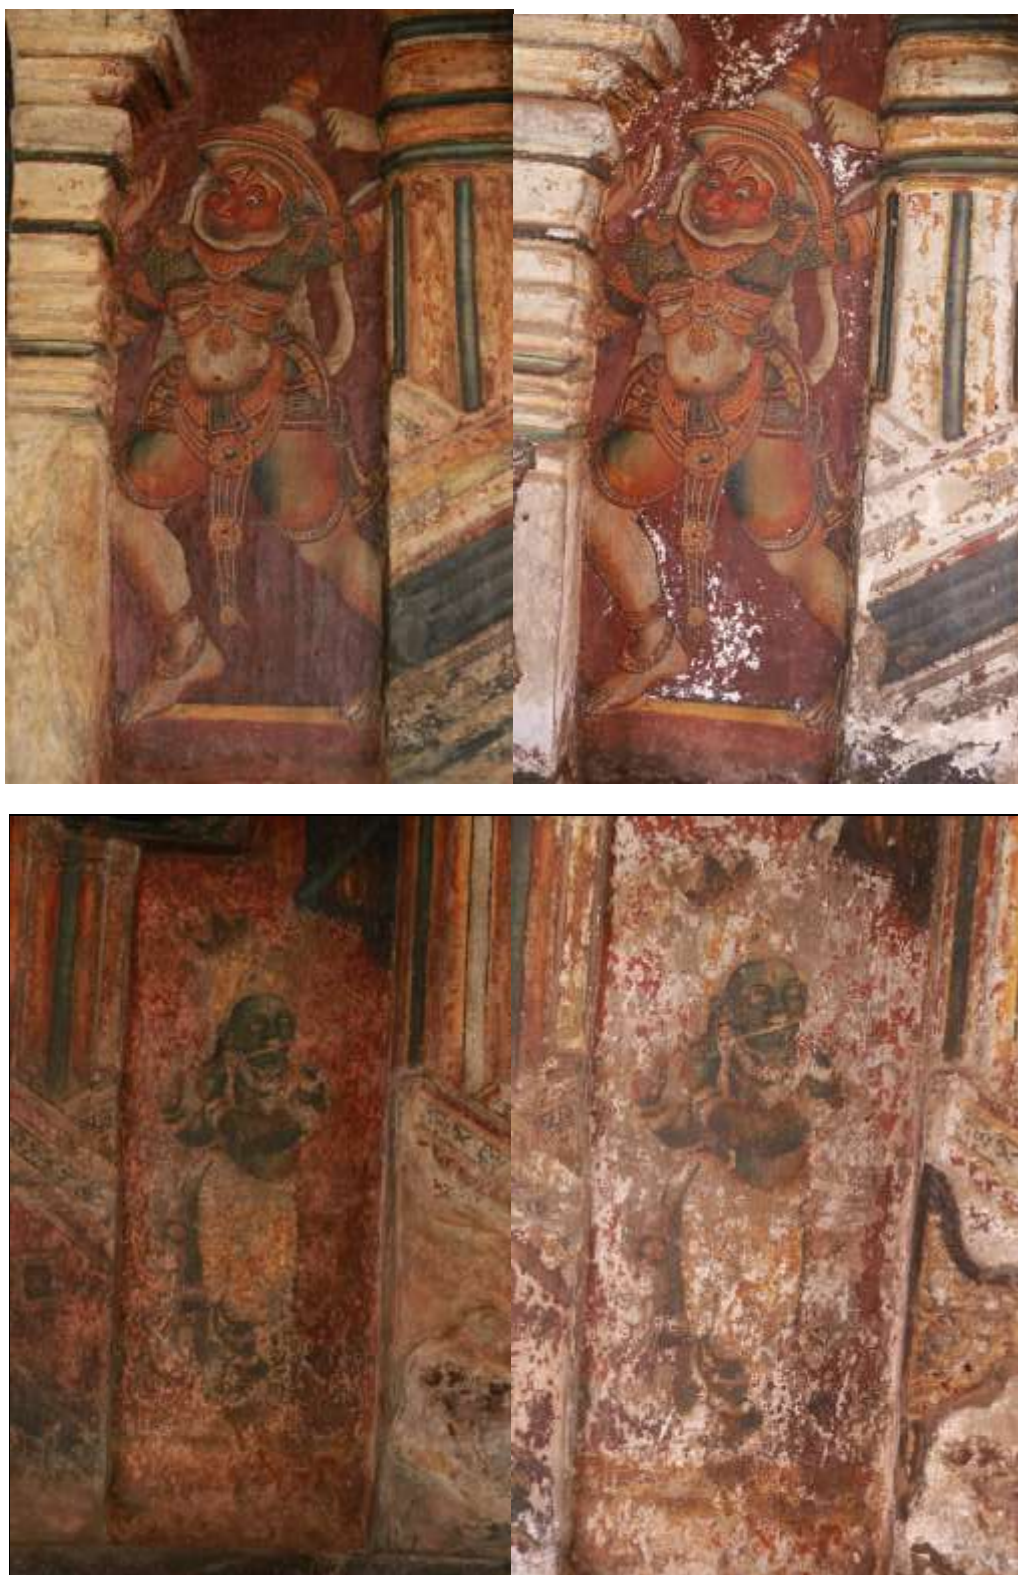
**E** before and after preservation – The iconographic feature depicts the panel of Hanuman at the top. This panel portrays the duel between Hanuman and Lanka Lakshmi (Situated on the left side of the Hanuman mural panel at circular Erattayappan Shrine which is missing at the current frame) and Lord Sree Krishna at the bottom. In both cases, the missing pigmented portions was subjected to colour reintegration along with rendering filling and filleting works where ever essentially required.

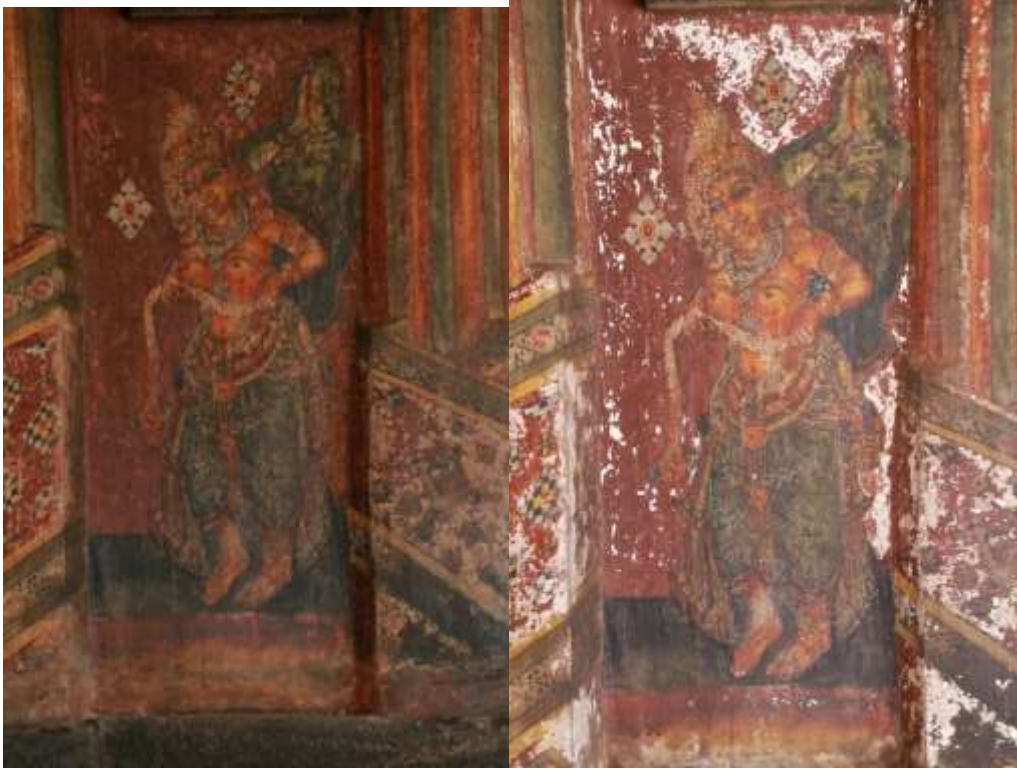
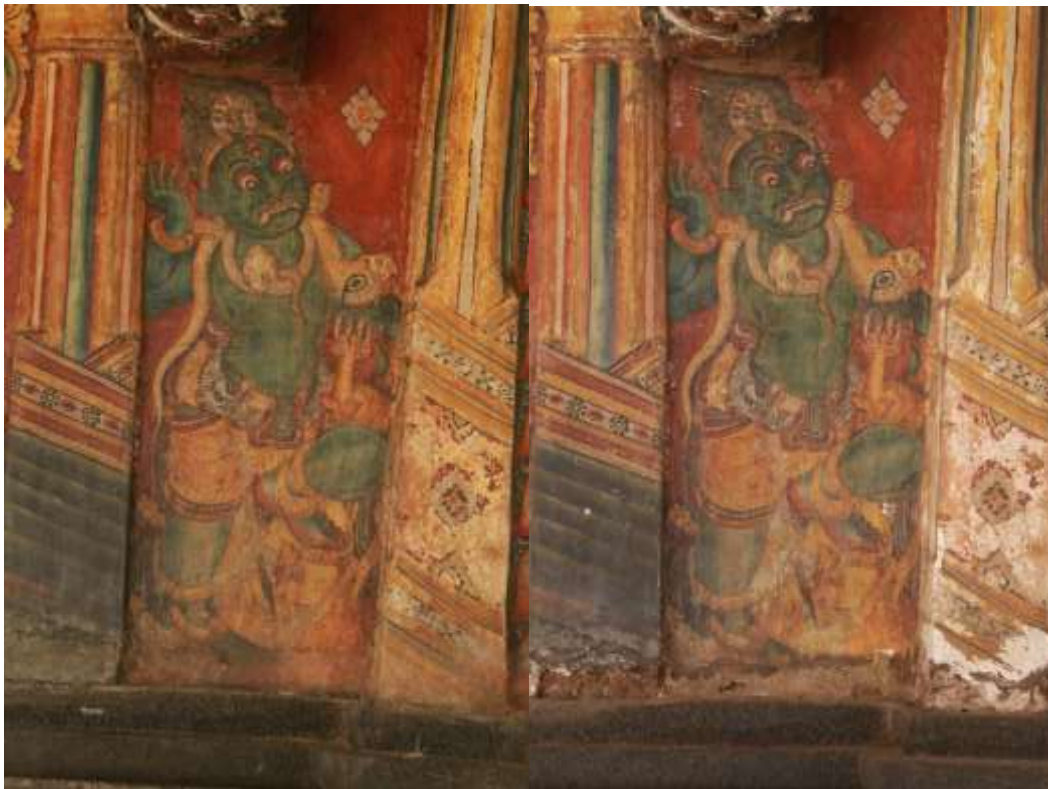
***Erattayappan Murals before and after preservation depicting Parvathy parinayam and Dwarapalaka on the other panel - The missing pigmented portions where colour reintegrated along with filling and filleting works concentrated at the base level of the mural painting.***
